EXAMINATION OF BLISTERING OF
FIBERGLASS REINFORCED LAMINATES

UNITED STATES COAST GUARD

June 26, 1987

BATTELLE
Columbus Division
505 King Avenue
Columbus, Ohio 43201-2693

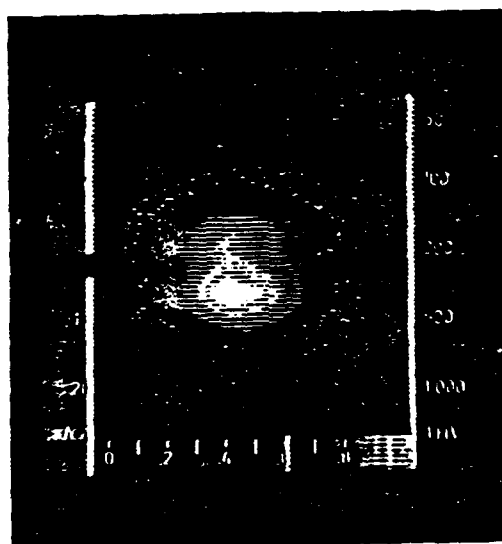
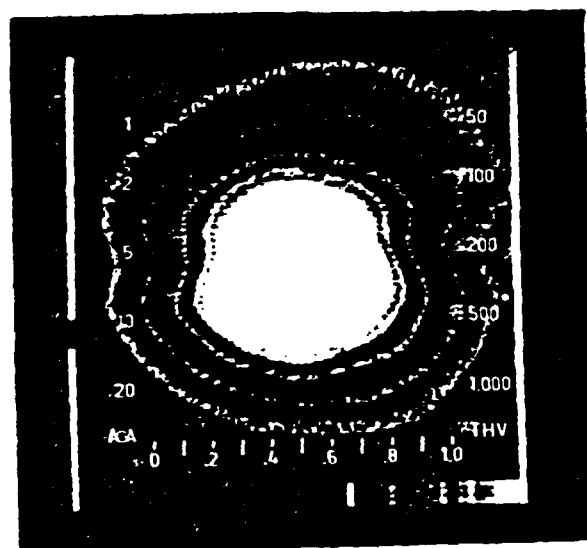
5A-C

displayed on a small television screen. Defects, when present, appeared as shown in Figures 1 and 2.

FIGURE 1. PANEL DEFECTS AS DETERMINED BY INFRARED CAMERA

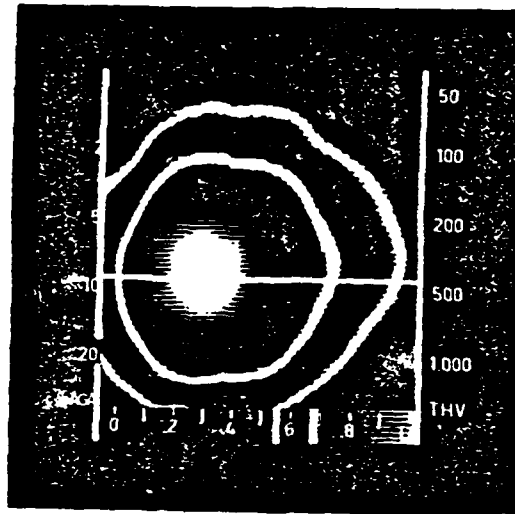
11
4A-C

FIGURE 2. PANEL DEFECTS AS DETERMINED BY INFRARED CAMERA
